UNITED STATES COURT OF APPEALS
FOR THE NINTH CIRCUIT

ALLIANCE FOR THE WILD ROCKIES,)	
)	No. 16-35856
Appellant/Plaintiff,)	
v.)	USDC No. 2:16-cv-00294-RMP
)	
JIM PENA, in his official capacity as)	
Regional Forester of Region Six U.S.)	
Forest Service, UNITED STATES)	DECLARATION OF
FOREST SERVICE, an agency of the)	NATALIE ERTZ
United States, and RODNEY SMOLDON,)	
in his official capacity as Supervisor of the)	
Colville National Forest,)	
)	
Appellees/Defendants.)

3. On October 15, 2016, I accompanied several individuals on a site visit to observe the conditions at the defendants' Onion Mountain Task Order Project Area in the Colville National Forest. This declaration is based on my observations made during the site visit to Onion Mountain on Saturday, October 15, 2016. I also took photographs during the site visit, and have attached several of the photographs below. Each of these photographic attachments is a true and correct copy of a photo I took on October 15, 2016, within the Onion Mountain project area. (Mr. North also calls this the "Onion Creek Task Order area." 2nd North Dec. at 4, par. 8.)

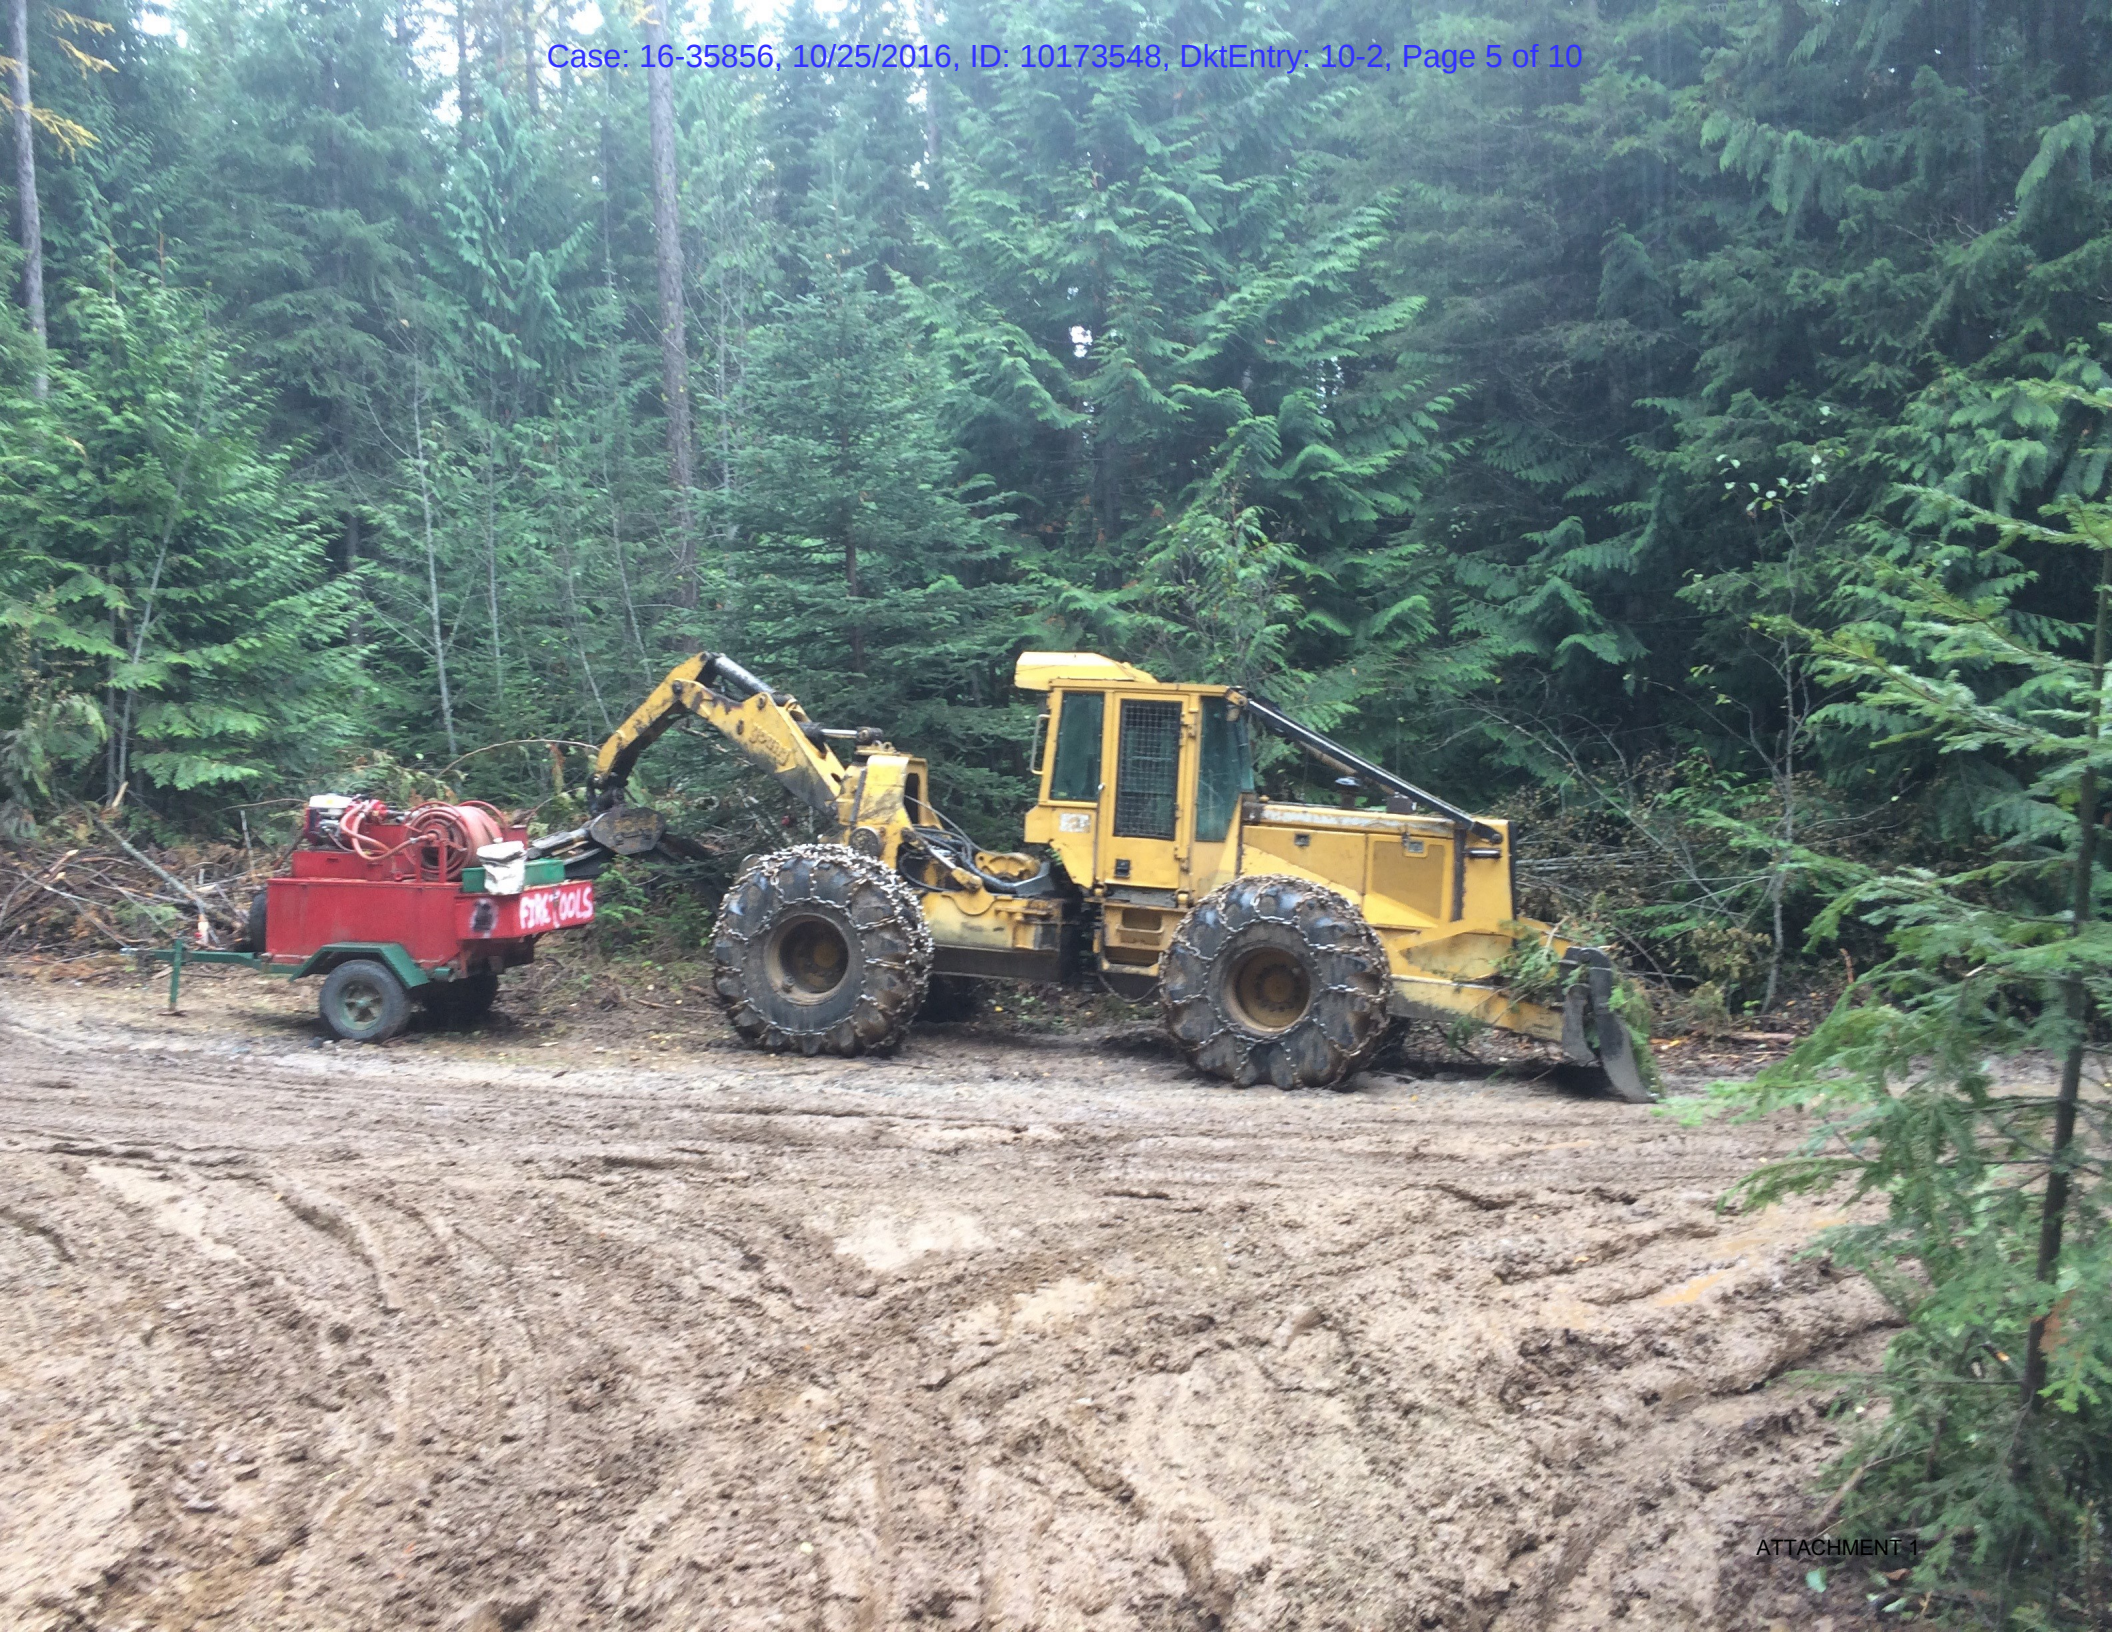
5. Attachment 1 to this declaration is a photo that accurately shows one of the intersections on the forest road within the Onion Mountain project area, looking east. The location of this road intersection is shown on Attachment 2 to this declaration, which is a true and correct copy of defendants' "Exhibit O" (DktEntry: 9-16) with a red circle added to show location. As

Attachment 1 shows, the forest road was very muddy and deeply rutted, with standing water pooled in some of the ruts.

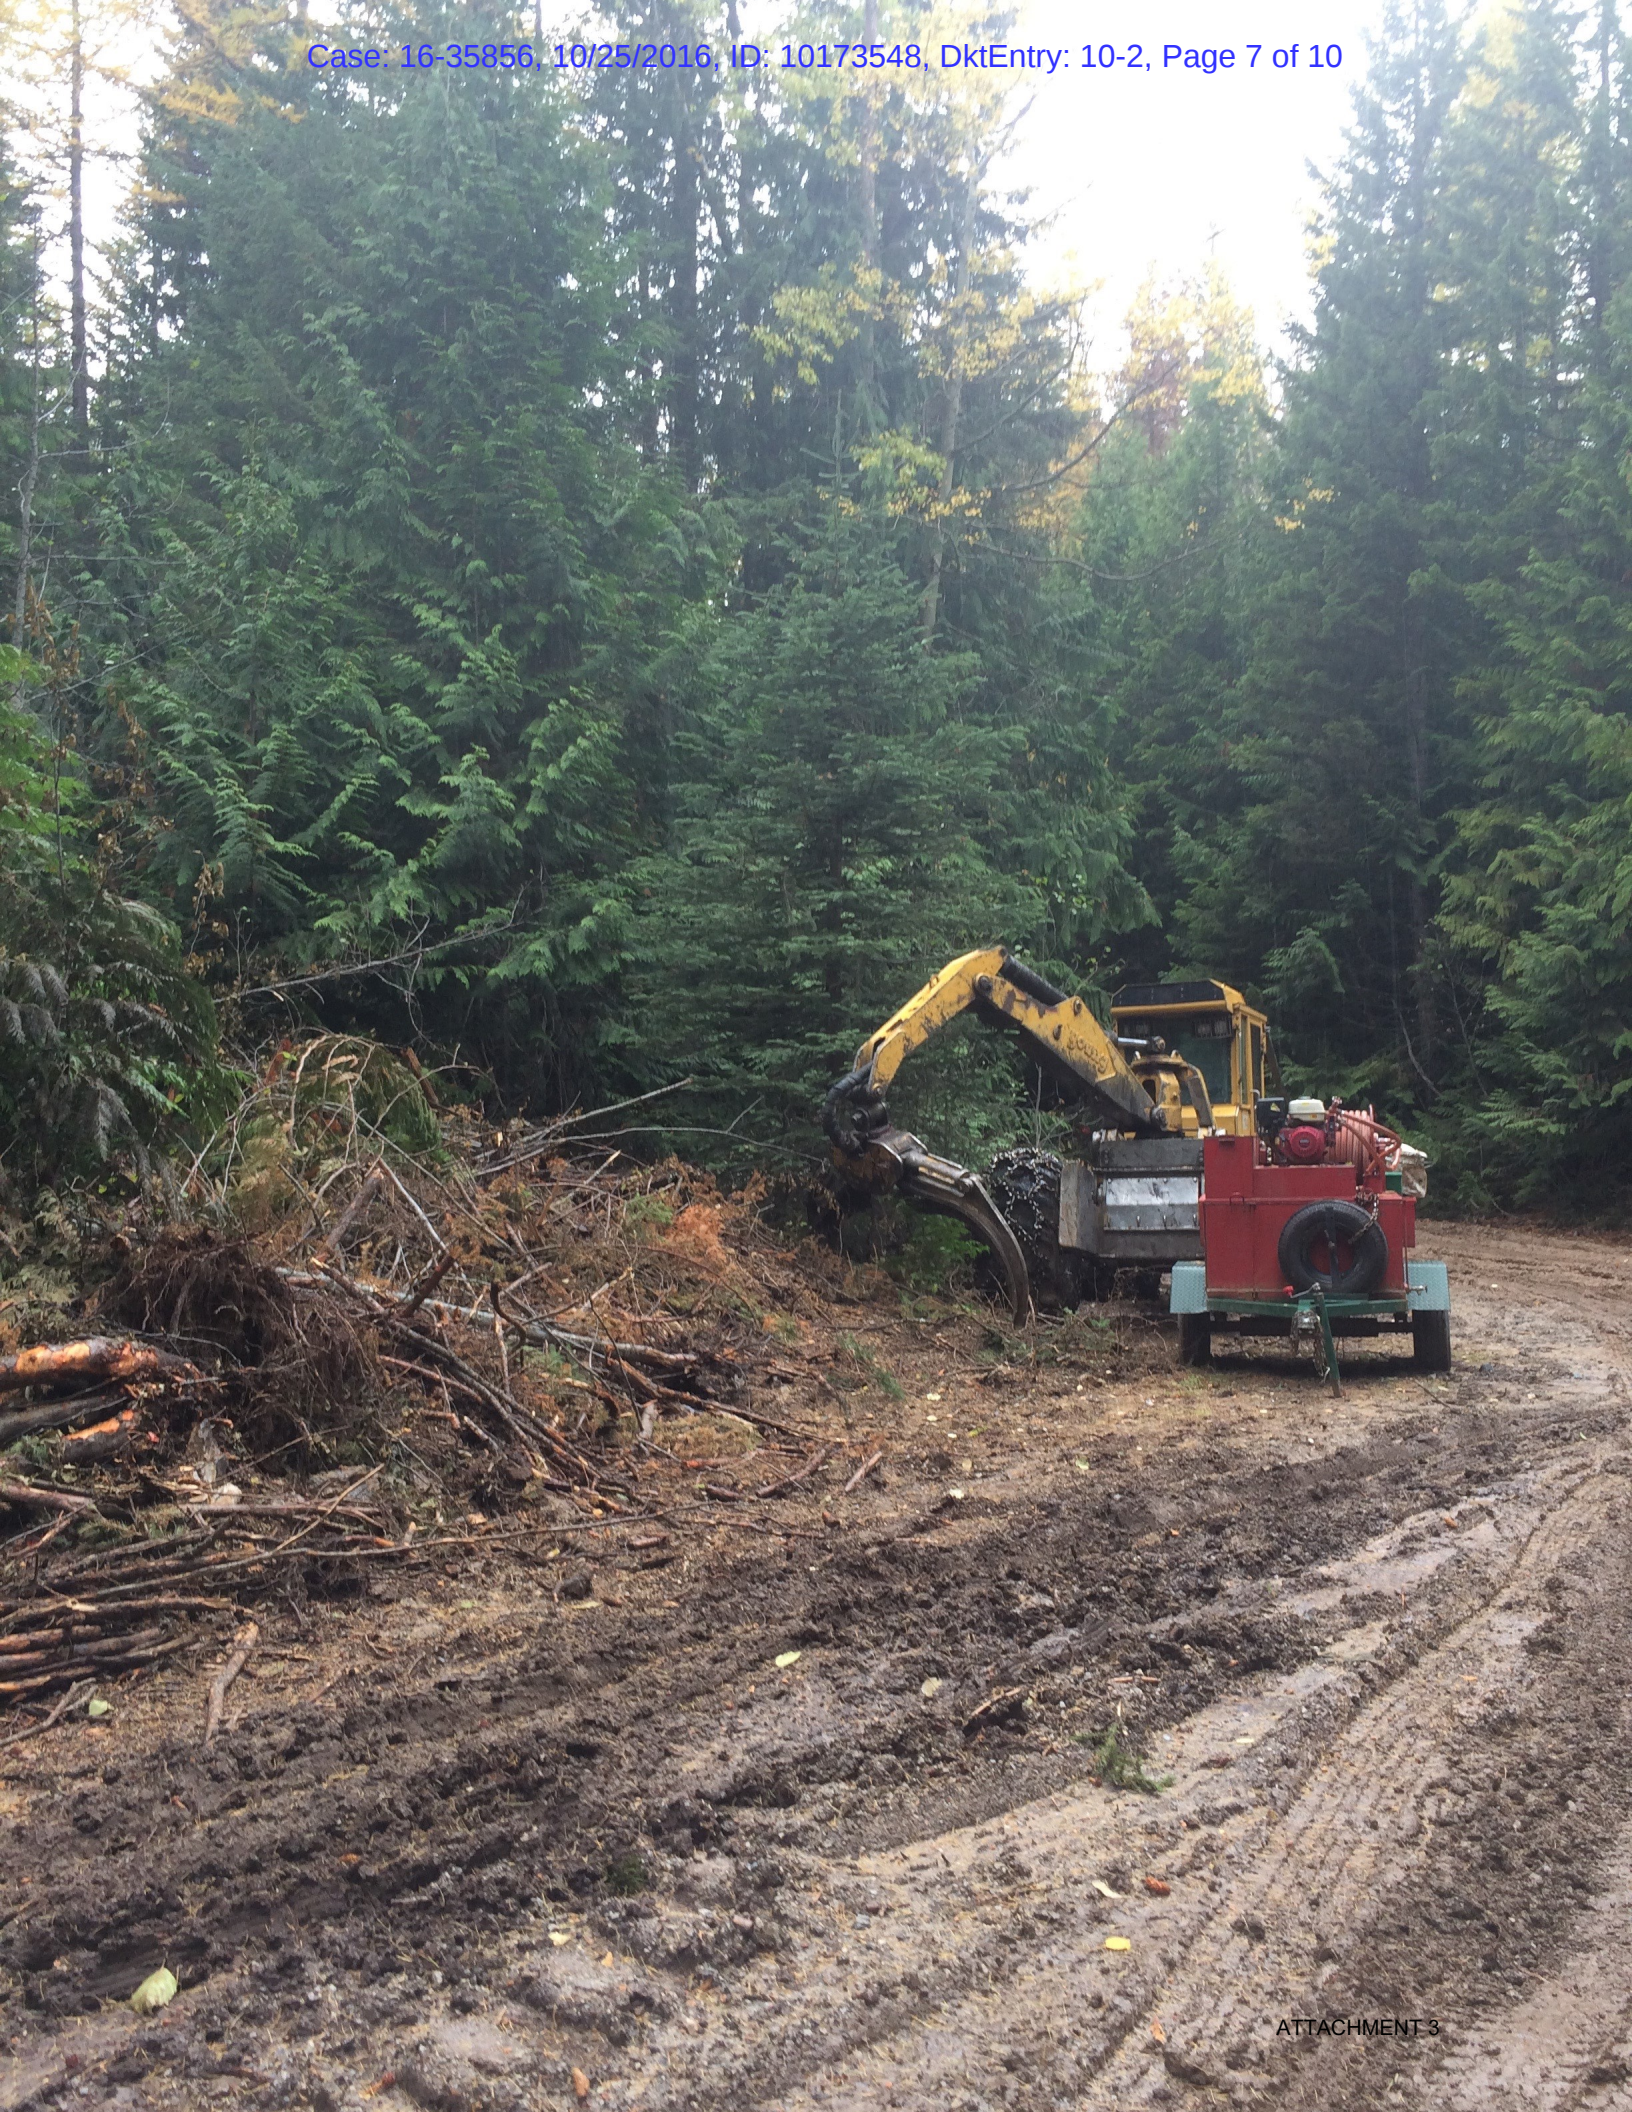
6. Attachment 3 accurately shows a different part of the same intersection, looking south. The same equipment as shown in Attachment 1 is seen here from a different angle. Again, the road is muddy and deeply rutted.

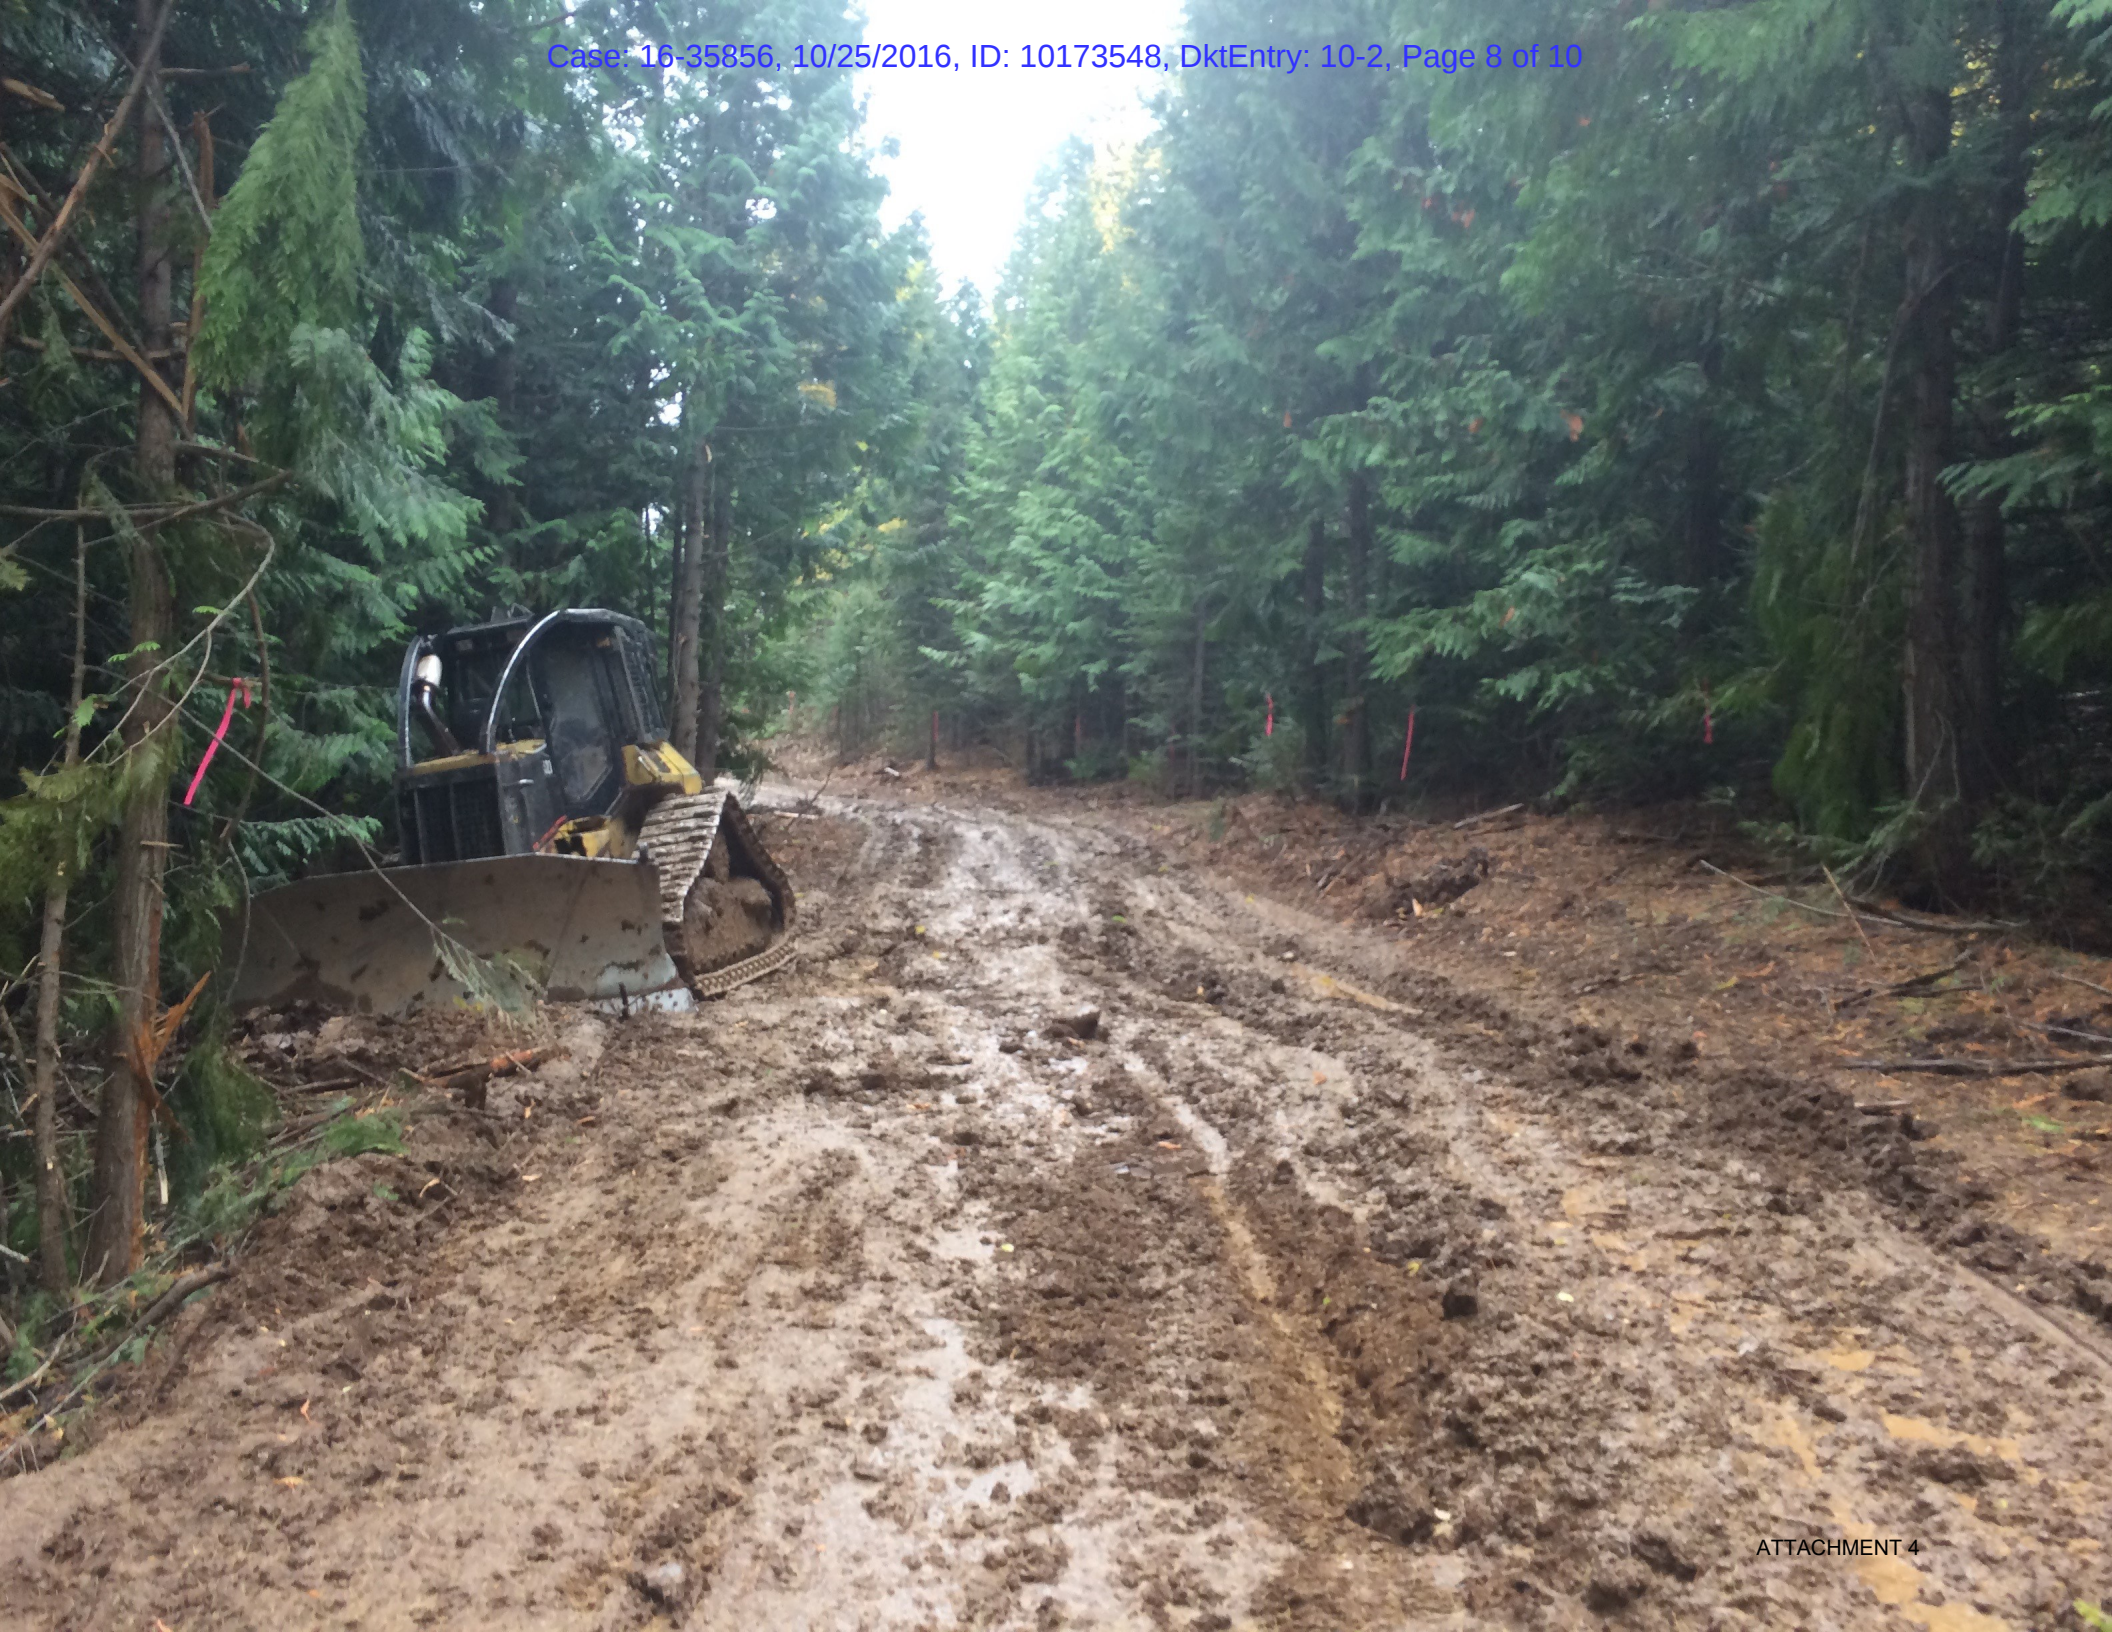
7. Attachment 4 accurately shows a part of the project road heading north from the intersection shown in Attachments 1 and 3. It was difficult to walk here because the road surface was very wet and muddy. I did not see any surface water controls on this road – no ditches, water bars, side drainage, or anything.

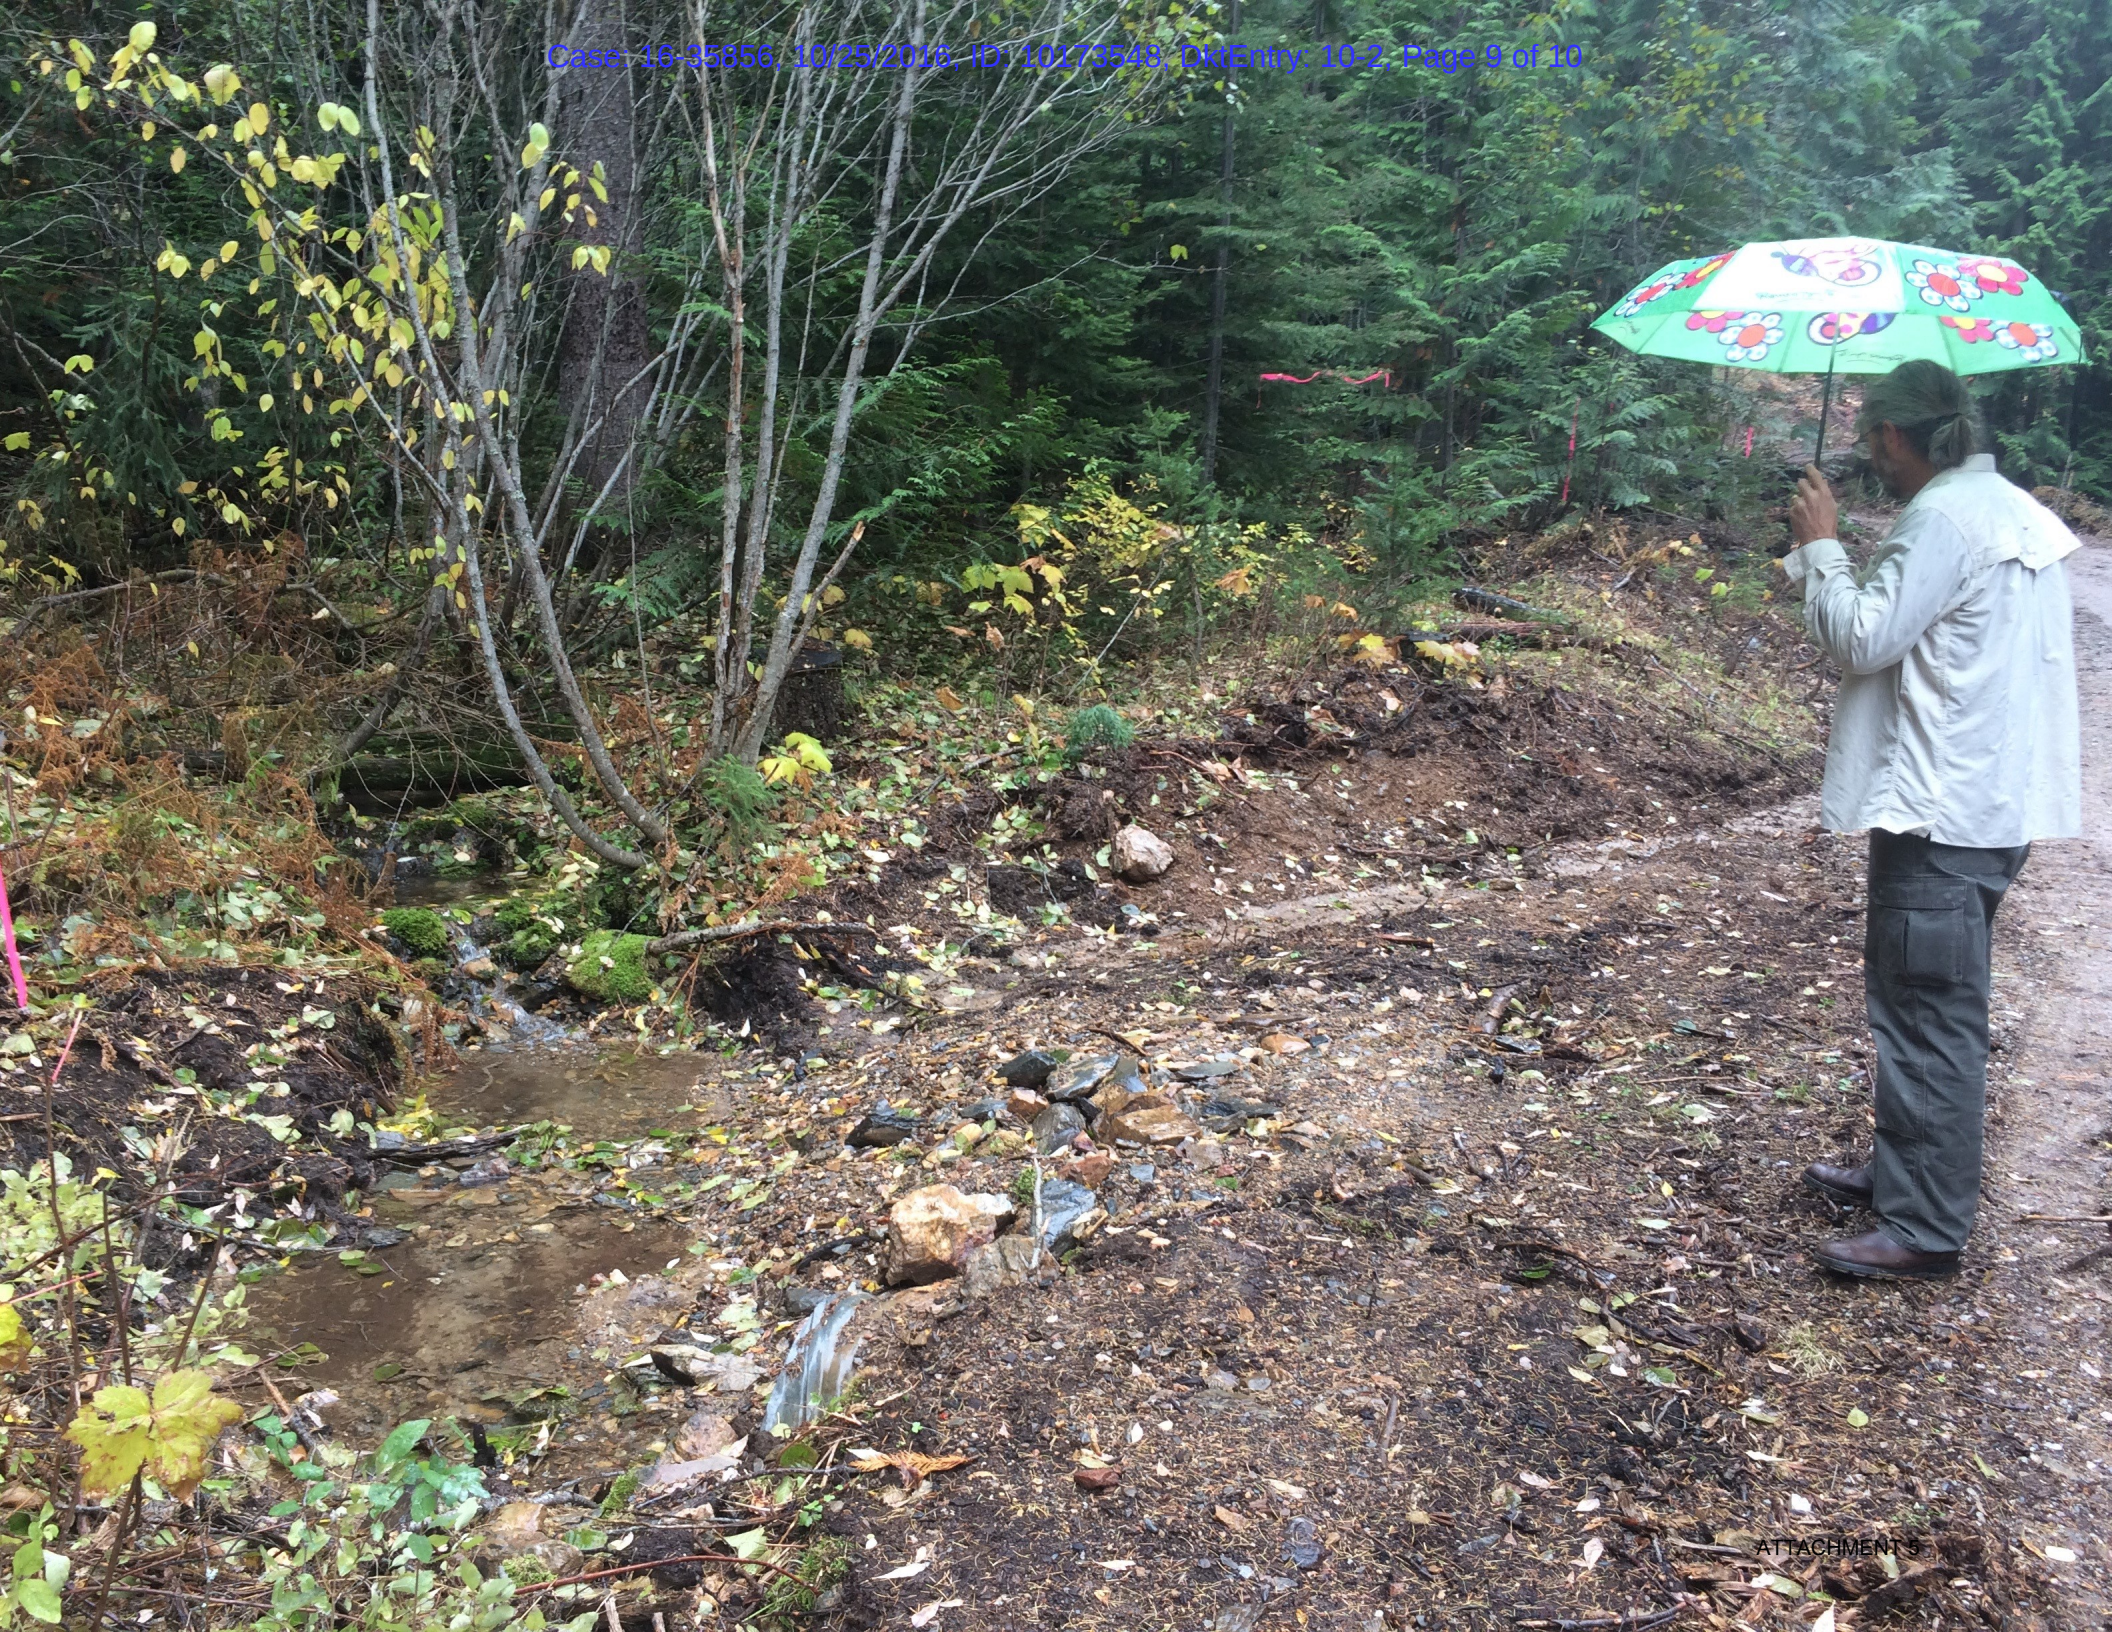
8. Attachment 5 accurately shows a feature alongside the Onion Mountain forest road, to the south of the intersection discussed above. As the photo shows, the road side ditch in the center and right side of the photo flows directly into a surface creek flowing down from the background on the left side of the photo. The combined flows then pass through a culvert at the bottom/center-left of the photo. There was nothing in the ditch or along the road, such as silt fences or hay bales, to prevent road runoff or ditch water from flowing directly into the creek.

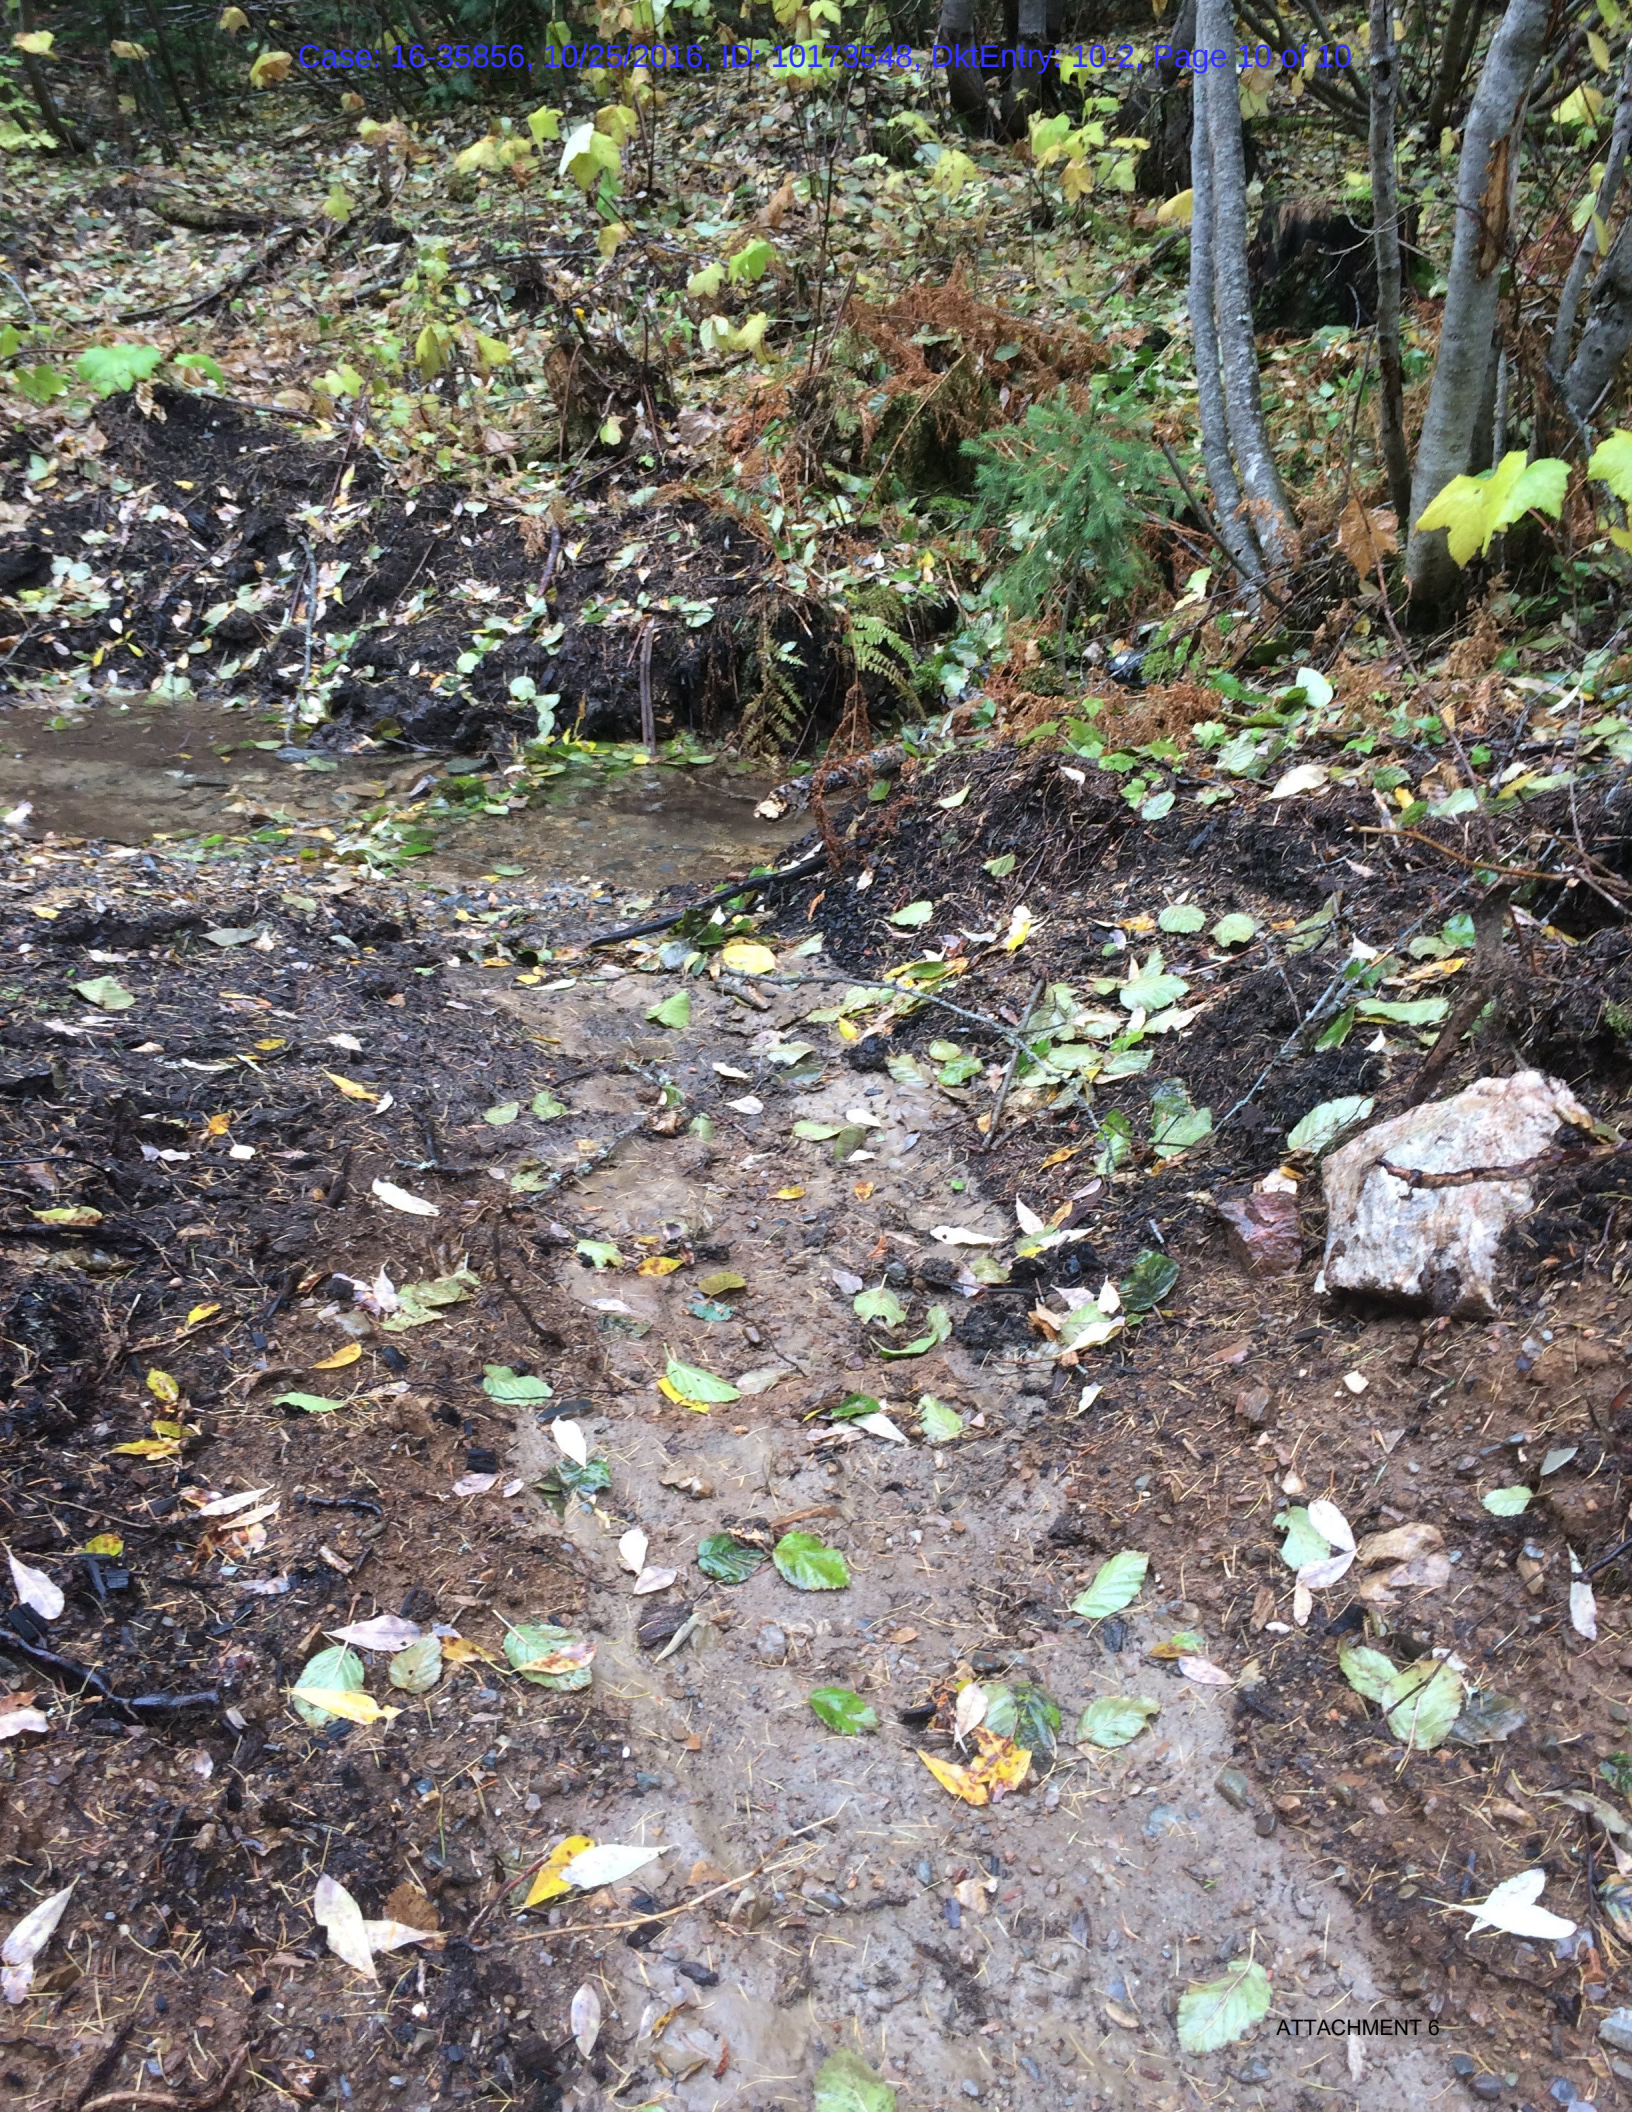
9. Attachment 6 accurately shows the same feature as Attachment 5, from a different angle. The ditch, in the foreground, flows away from the camera to join the creek, which flows in from the upper right side of the photo. Although it had not rained enough to produce steady runoff while I was there, I saw silt in the ditch and clear indications of past flows into the creek at this point. The culvert opening is just beyond the edge of the photo on the left side of the creek.
